# Manhole Inspection Summary

Manhole # S23GG1016MH

Insp Date: **12/11/06 2:08 PM**

**Location** Address: **4102 EDGEHILL AVE**

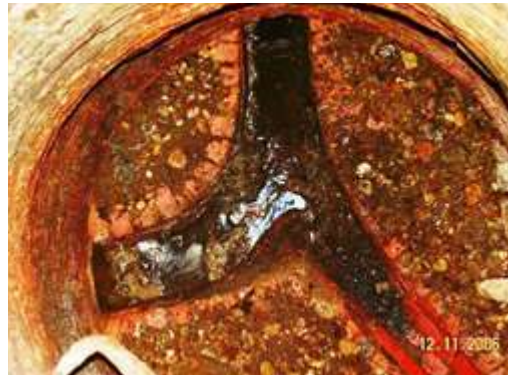
Top View

Barrel infiltration. Corroded steps.  
Evidence of surcharge - Bench debris.  
Channel debris.

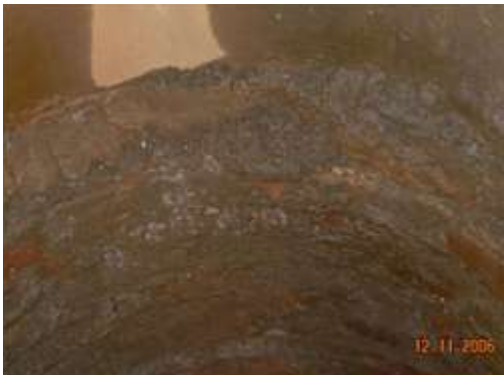
Defect

**Frame** Offset: **2** (in.) Condition: ☐ Sound ☐ Cracked ☒ **Leaks**

Condition: ☐ Sound ☐ Cracked ☐ Root Intrusion ☐ Loose Brick ☒ **Deteriorated**

Infiltration: ☐ None ☒ **Joint** ☐ Cracks ☒ **Mortar** ☐ Roots ☒ **Wall**

Frame leaks. Adjustment deterioration  
and infiltration.

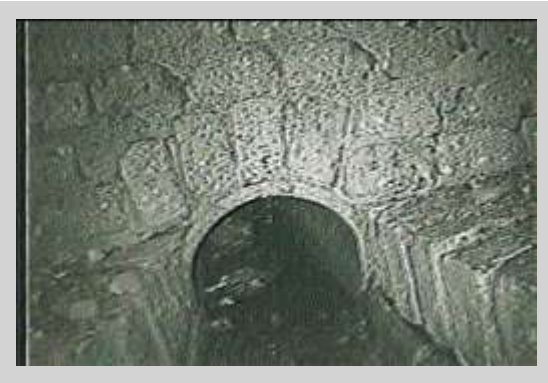
### 8 in. Circular Gravity Sewer Pipe Out @ 12 O'Clock

Channel deterioration.

Deposits: ☐ None ☒ **Mud** ☐ Sludge ☒ **Debris** ☐ Grease

Silt Depth: **0.5** (in.) Deposits Extent: **Light**

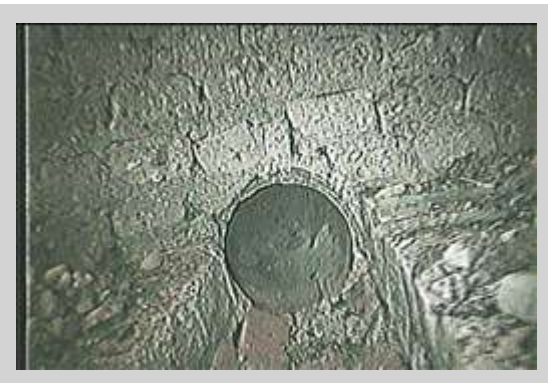
### 6 in. Circular Gravity Sewer Pipe In @ 4 O'Clock

Deposits: ☐ None ☐ **Mud** ☐ Sludge ☒ **Debris** ☐ Grease

Infiltration: **Evidence** Pipe Seal Cond: **Cracked**

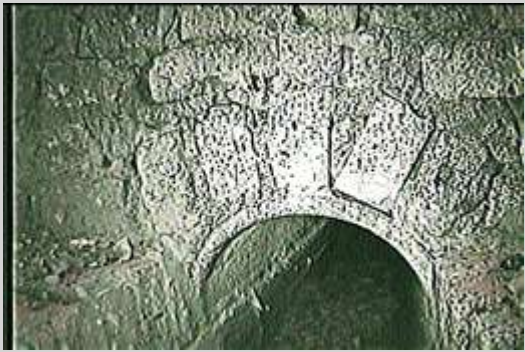
8 in. Circular Gravity Sewer  
Pipe In @ 9 O'Clock

Barrel deterioration and infiltration.

Deposits: ☐ None ☒ **Mud** ☐ Sludge ☒ **Debris** ☒ **Grease**

Silt Depth: **0.5** (in.) Deposits Extent: **Light**
